# SHIPS' SAFETY BULLETIN

JANUARY-MARCH 2010

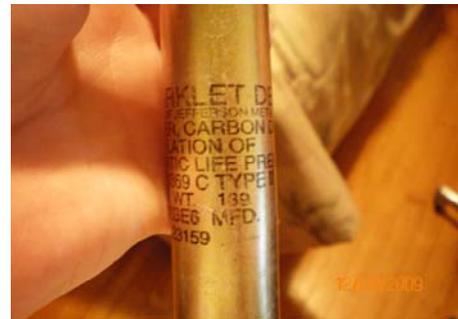
During safety surveys, we continue to find these out in the fleet. There are many Mk-1 and abandon ship life jackets with these CO<sub>2</sub> cylinders installed. Supervisors must inspect Mk-1 and abandon ship life preservers to see if they have the recalled CO<sub>2</sub> cylinders installed. If your cylinders are identified as "Recalled," do not use them.

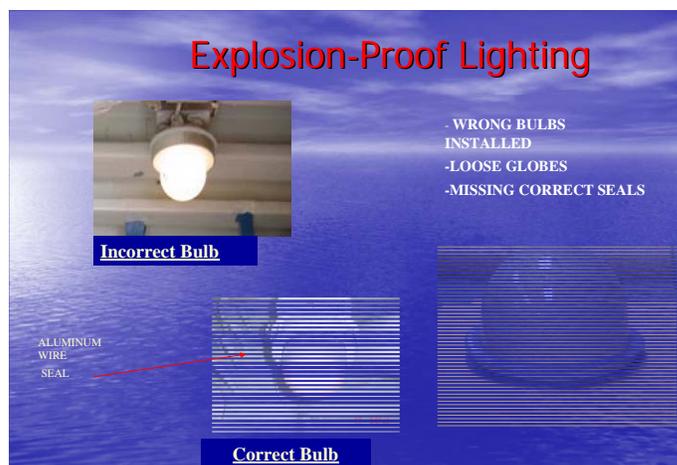
In the last nine safety surveys conducted onboard ships, all had significant discrepancies with their explosion-proof lighting. The main problems seem to stem from ownership and lack of training for those who perform the maintenance.

**Bulbs:** In spaces that are used heavily, e.g., hazmat where the light bulbs require frequent replacement, the fixtures are not tightened properly and tamper seals are not installed. The MRC requires an electrician to conduct maintenance on the fixtures. However, frequently personnel tell me that personnel assigned to the effected space are replacing the light bulbs without consulting the electrician's mates. Therefore, they are installing incorrect bulbs. Ensure you use a 110-watt, 120-volt reflector-type bulb. Replace burned out or incorrect bulbs with NSN 6240-00-578-6820.

**Gaskets:** The globe fixture is sealed using two lead gaskets, an upper and lower. Both must be installed to ensure an explosive-proof seal. Since they are lead and easily compressed, the globe must be checked for tightness, and gaskets replaced if the globe is loose when the 1/8-inch seal holes are aligned. You can order the correct lead gaskets using NSN 5330-01-046-0440.

**Seals:** In fixtures designed for seals, align the 1/8 inch hole in the globe supporting ring to match the slot in the box flange and install an aluminum seal. Only in spaces subjected to heavy vibration causing frequent bulb replacement or tightening, can you use plastic tamper seals. Order the correct aluminum seals using NSN 5340-00-522-2514.

Explosion-proof lighting can be effective in the prevention of fires **ONLY** when properly maintained. Senior leadership, this is an outstanding check to perform a spot check on, and should be checked on regularly.
