Mech

Night Flight Deck Maintenance
3 Points of Contact
Fall Protection Pullout

**The Navy & Marine Corps
Aviation Maintenance Safety Magazine**
Summer 2015, Volume 53 No. 1

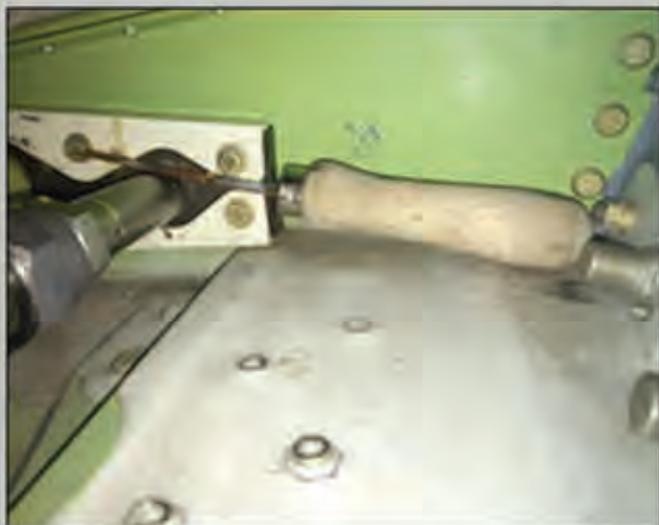
In the photo on the opposite page the tool is barely visible, but when compared to this photo it becomes evident. This photo shows the entire tool used to install Adel clamps on the aircraft, yet, it is not a part of VP-5's tool inventory.

In this case, we were surprised to find an unknown tool that had clearly suffered the wear of time and moisture. It was heavily corroded, resting on a spot on the hydraulic line that appeared to be flattened out over time. The tool did not have any VP-5 markings nor was it a recognized tool in our squadron inventory.

The tool had originally been used to install Adel clamps. It had a small wooden handle and a thin, rectangular blade. It posed a serious threat to the safety of the aircraft while trapped away in the confines of the 431DL panel. Because of the constant flowing of hydraulic fluid throughout all phases of flight, the hydraulic

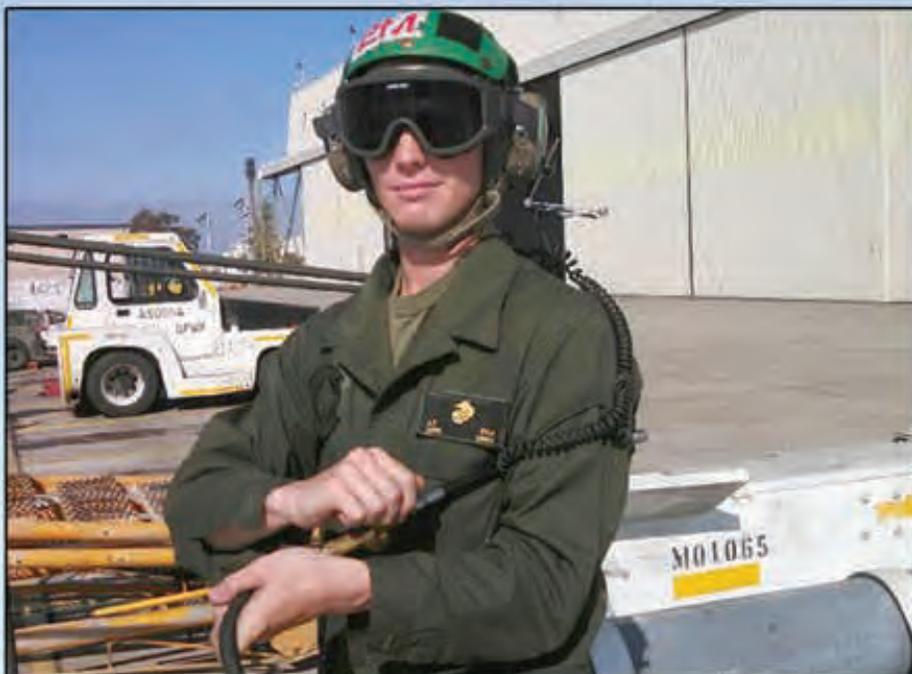
Lance Corporal Zyla demonstrates the three points of contact which should be used when handling highly pressurized hoses/systems like that of the NAN-cart.

order to bleed down the manifold pressure. LCpl Lopez proceeded to turn off the pump as I grabbed the hose and put it underneath my arm with three points of contact with the nozzle facing behind me.

If anyone should learn anything from this accident, it is that they should be cautious of the pressure in hoses and tanks. Pre-operation is just as important as proper PPE. Even though the laceration was under my goggles, having my cranial on saved me from getting hit in the eye. I could have lost an eye. So always keep three points of contact on pressurized hoses from the NAN-cart and have a firm grip.

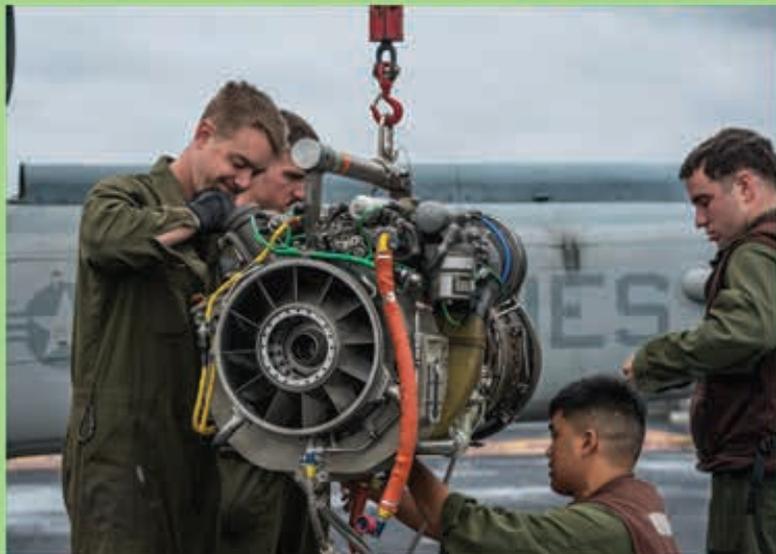
Marines assigned to 31st MEU perform maintenance on the engine of a UH-1Y Huey helicopter on the flight deck of the USS *Bonhomme Richard* (LHD 6). (U.S. Navy photo by MC3 Kevin Cunningham)

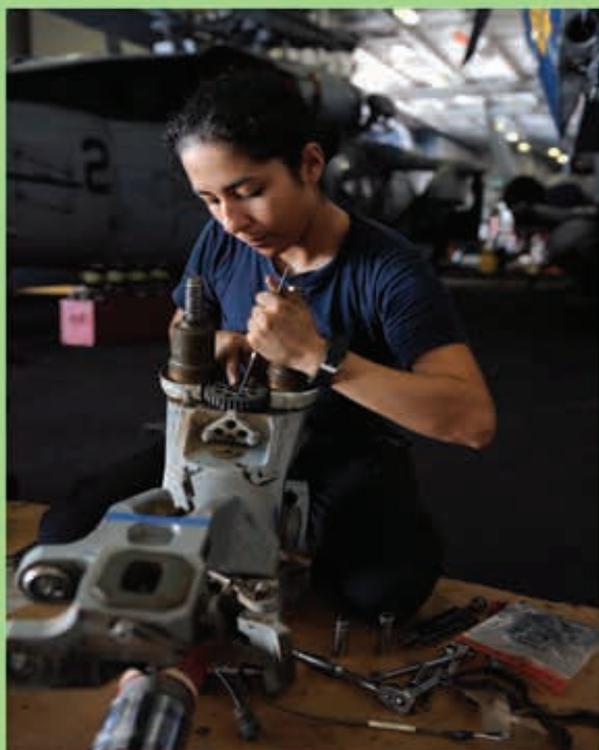
AM2 Jessica Gonzalez assigned to HSC-6, takes apart a spindle for a rotor head on an MH-60S helicopter in the hangar bay of the USS *Nimitz* (CVN 68). (U.S. Navy photo by MCSN Siobhana R. McEwen)

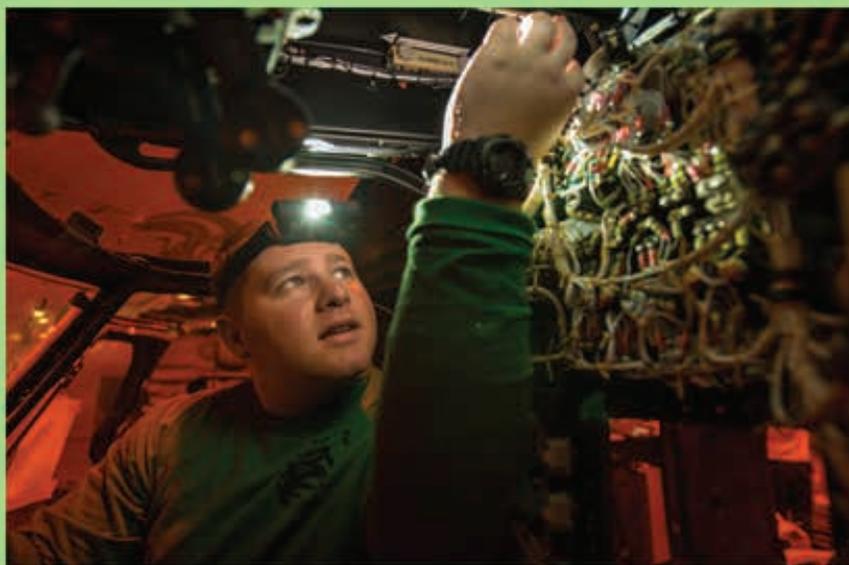
AE2 Nick Lacey, assigned to HSC-15, inspects the electrical system of an MH-60S Sea Hawk helicopter in the hangar bay of the USS *Carl Vinson* (CVN 70). (U.S. Navy photo by MC2 John Philip Wagner)

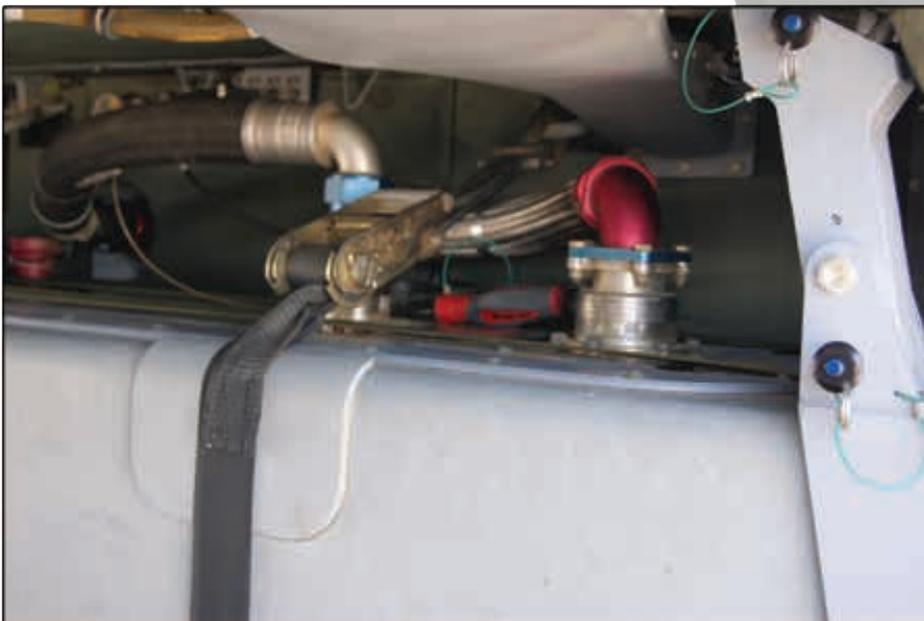
The screw driver is just barely visible under the strap lockdown.

my own tool pouch, nor did I have the plane captain take a look at my tools. That was mistake number three. Always check all of your tools before leaving the aircraft. Had I complied with that simple procedure, I would have noticed that the flathead was not in the pouch, and the helicopter would never have started up, engaged rotors and launched with a screwdriver sitting on top of the fuel tank.

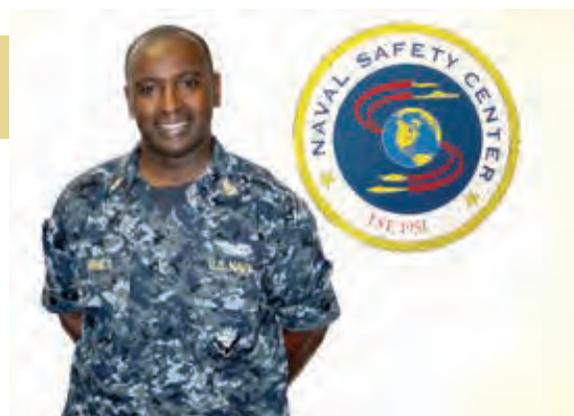
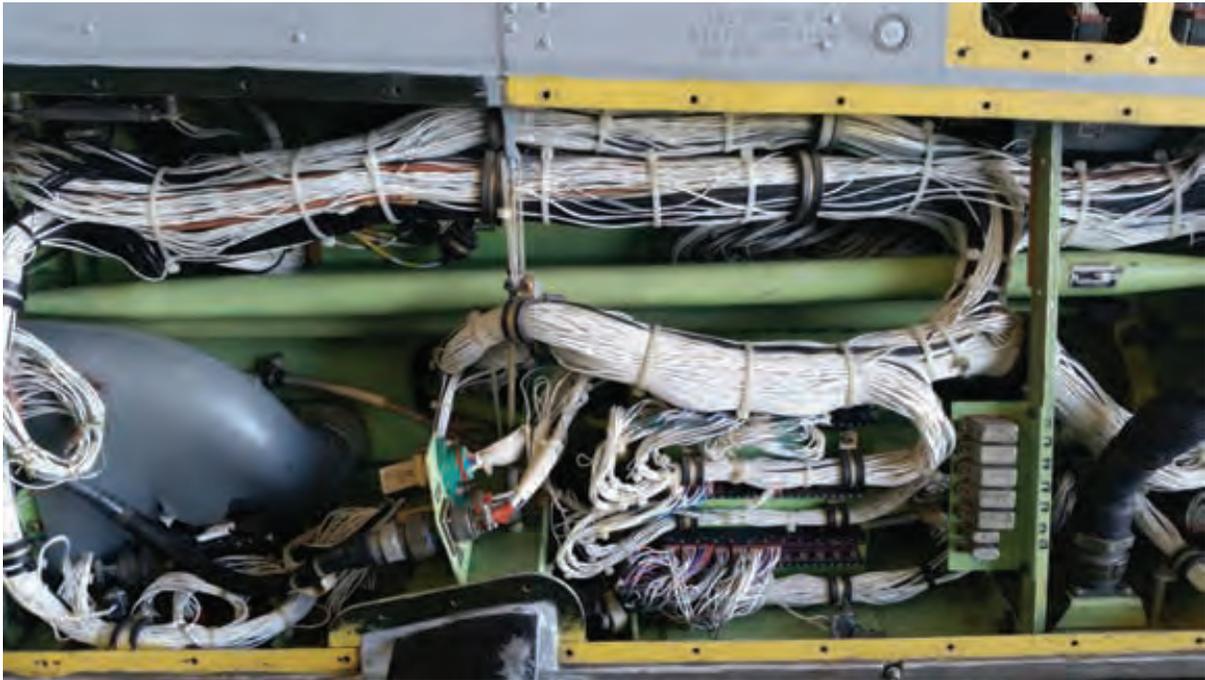
The INSTALLATION AND REPAIR PRACTICES VOLUME 1 AIRCRAFT ELECTRIC AND ELECTRONIC WIRING: NA 01-1A-505-1, WP 10, para 69 states: use of plastic cable straps (Zip Ties) is strictly prohibited in all instances.”

Assessment visits to a variety of Navy and Marine Corps units has revealed a shocking discovery, the use of zip ties to secure wiring in our aircraft. Seems like no big deal right. WRONG! It's a huge deal. The use of zip ties can result in chaffing of wiring. Which causes shorts, leading to catastrophic events. Also, FOD is an issue as they age, become brittle and the locking mechanisms break. Imagine a zip tie that finally fails and migrates towards an area to jam a primary flight control just as that aircraft is taking off the front end of the flight deck. You guessed it...a recipe for disaster. However, this is

The *INSTALLATION AND REPAIR PRACTICES VOLUME 1 AIRCRAFT ELECTRIC AND ELECTRONIC WIRING*: NA 01-1A-505-1, WP 10, para 69 states: "The use of plastic cable straps (Zip Ties) is strictly prohibited in all instances."
