Mech

Winter 2015

Growler Gets Hammered
Brainstorms and Rewards
Fall Protection Pullout

**The Navy & Marine Corps
Aviation Maintenance Safety Magazine**
Winter 2015, Volume 53 No. 2

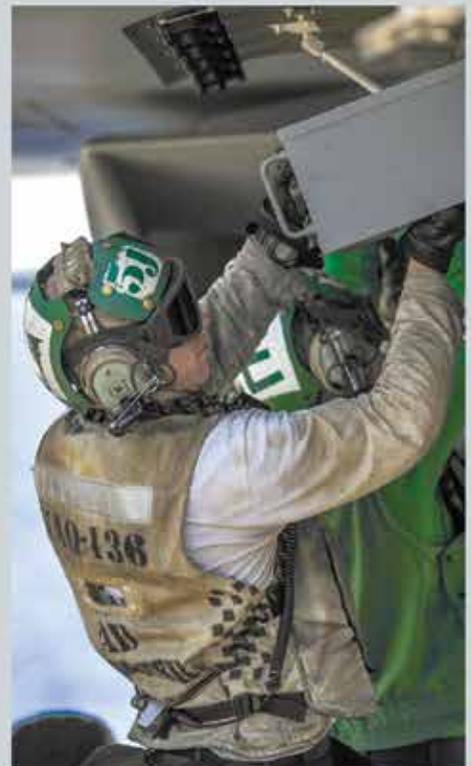
AT2 John Hall, assigned to the VAQ 136, unloads a flight control computer from an EA-18G Growler aboard USS Ronald Reagan. (U.S. Navy photo by MC3 Andrew J. Ulm)

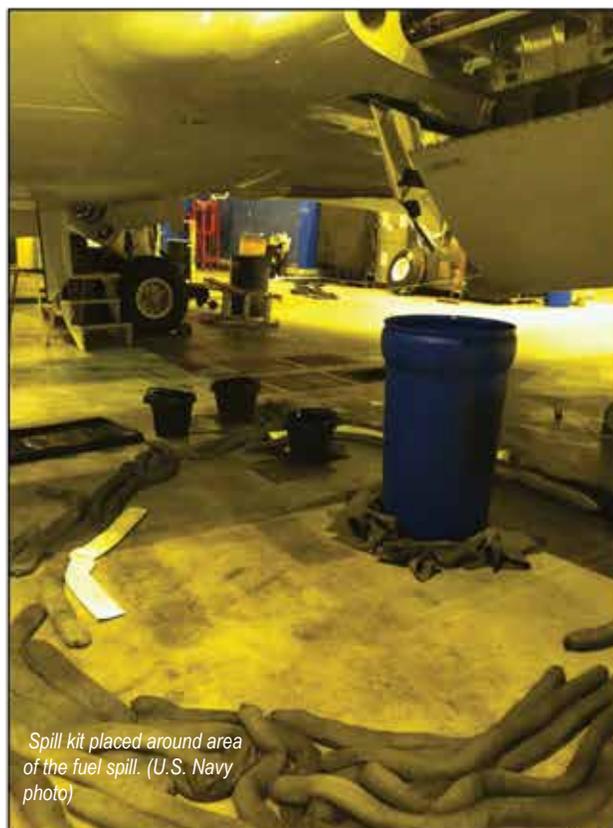
Spill kit placed around area of the fuel spill. (U.S. Navy photo)

The two maintainers returned to the spill. The CDI donned the PPE in the kit and tried to reinstall the seal sleeve and valve. Once the sleeve was in, the valve was reinstalled enough to slow the leak to a manageable seep. By this time, the CDI was soaked in fuel; he was released to go take a shower. The duty fire marshal arrived and concluded that even though fuel was still seeping, the scene was contained. After working for about an hour to stop the seep, personnel concluded that the sleeve was twisted and needed to be removed and reset to allow the valve to be reinstalled. They did so, and the seep stopped.

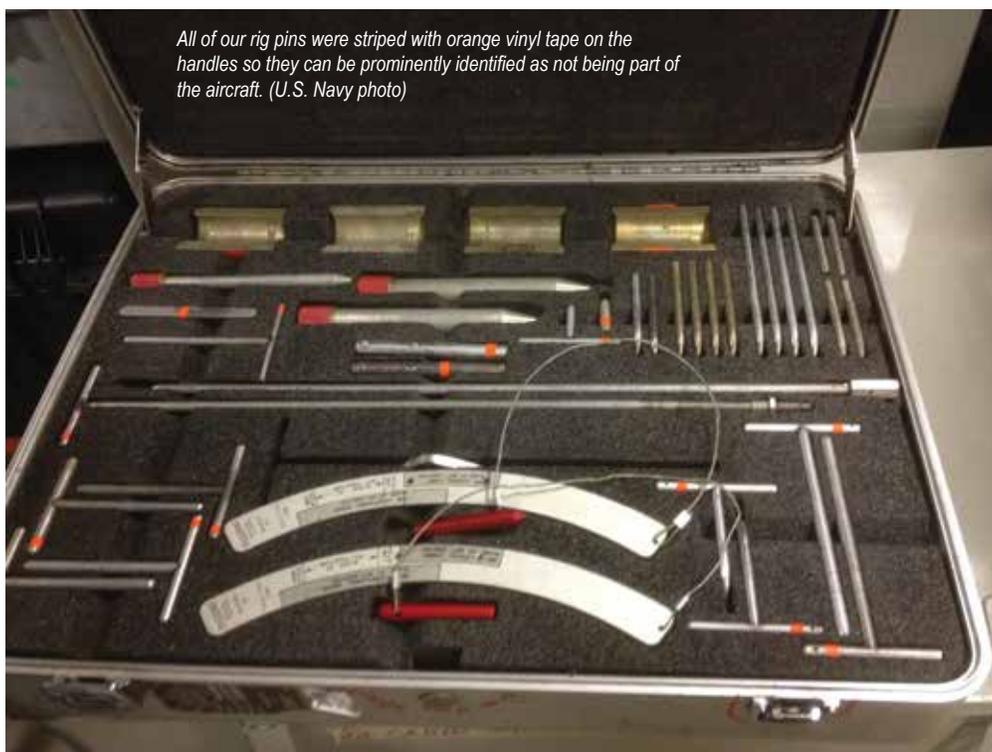
All of our rig pins were striped with orange vinyl tape on the handles so they can be prominently identified as not being part of the aircraft. (U.S. Navy photo)

I couldn’t have identified that the rig pin as anything other than another piece of the tail-rotor gear- box.

Some special audits and counseling sessions were conducted, and some procedures augmented for the better, but no one was hurt. The primary corrective action we put in place in our squadron to prevent this from happening in the future was to have all our rig pins striped with orange vinyl tape on the handles so they can be prominently identi- fied as not being part of the aircraft.

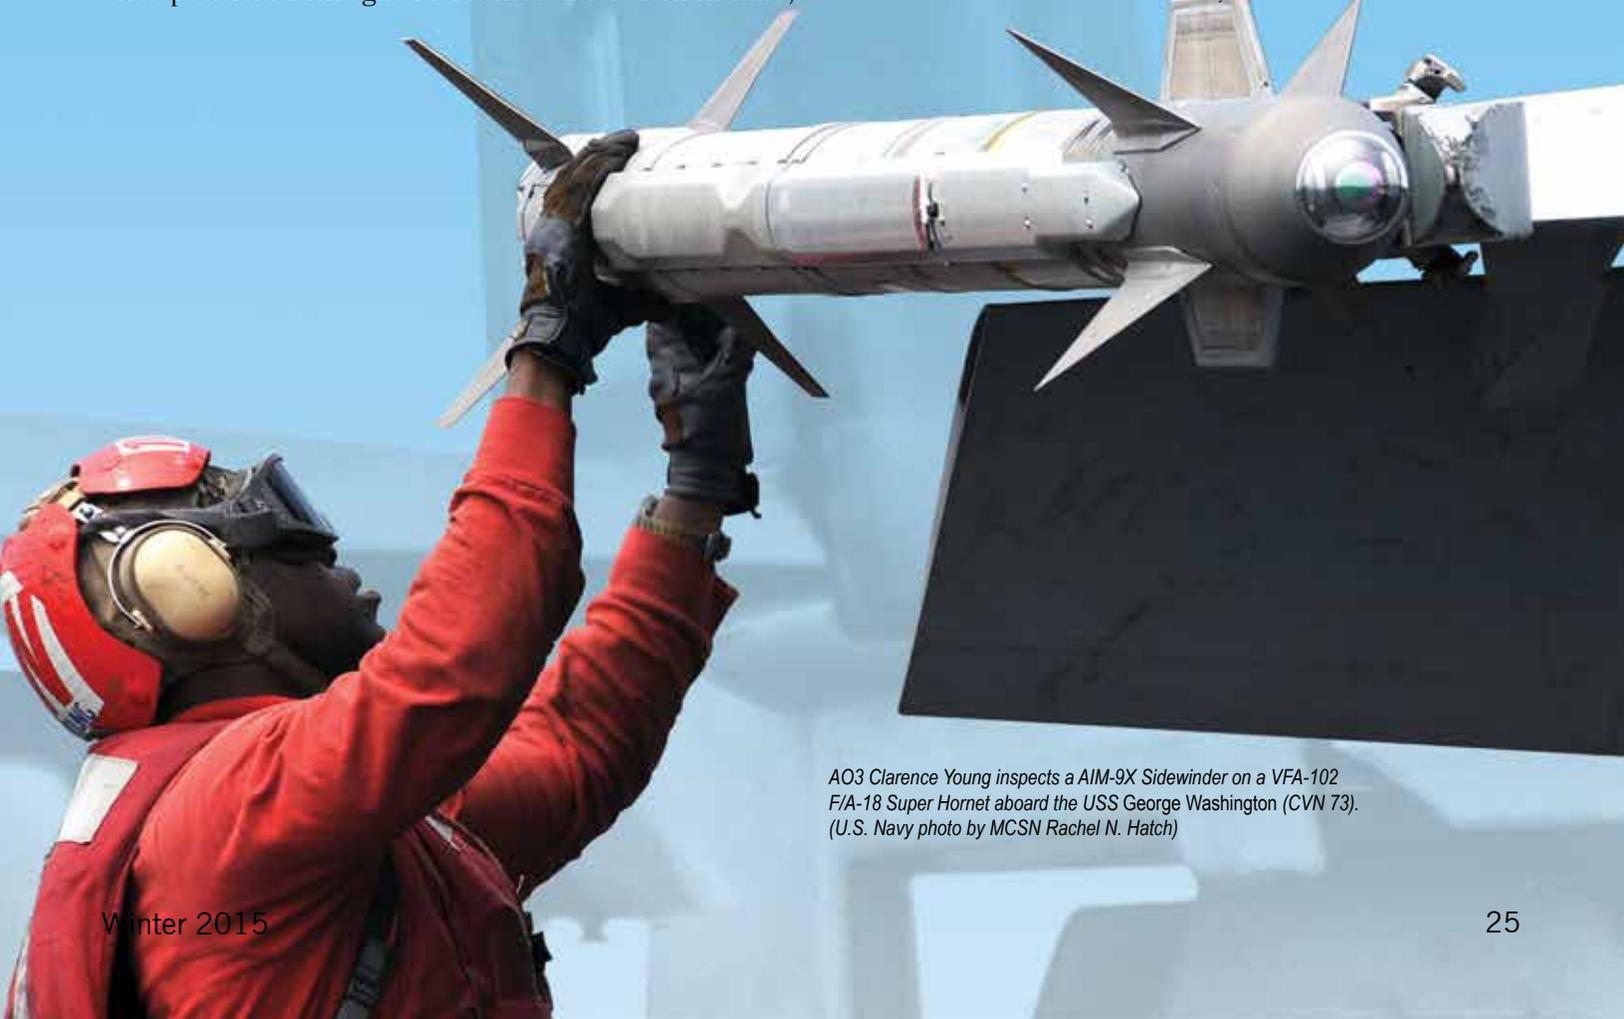
AO3 Clarence Young inspects a AIM-9X Sidewinder on a VFA-102 F/A-18 Super Hornet aboard the USS George Washington (CVN 73). (U.S. Navy photo by MCSN Rachel N. Hatch)
