THE NAVY & MARINE CORPS AVIATION SAFETY MAGAZINE

www.public.navy.mil/navsafecen/ • January - February 2014

Approach

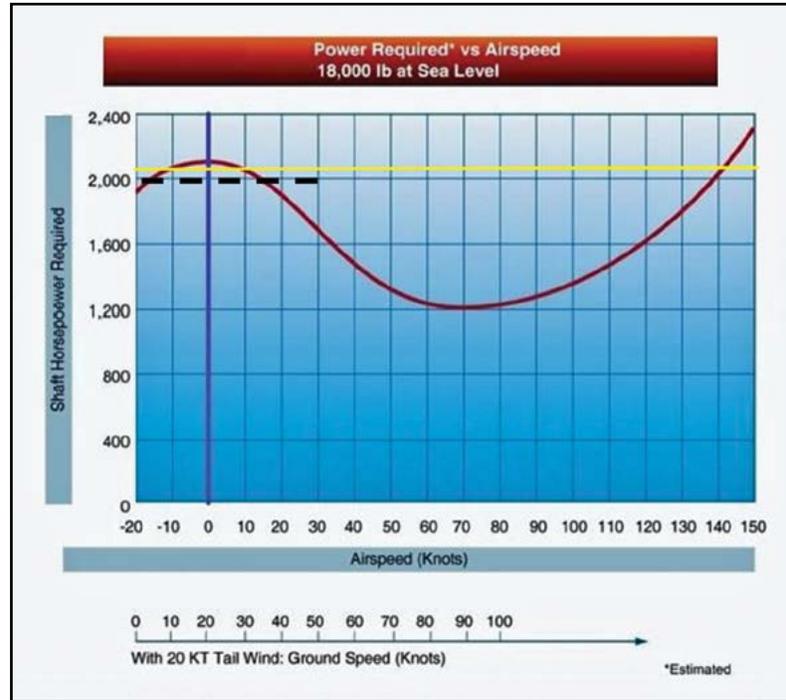
Fig 3. Tailwind Effect on Power Required Curve (modified).

power required is shown by the red curve, and power available by the yellow line. Power-wise, a 13-knot tailwind feels like 12 knots on the nose (see dashed black line). But with the headwind, power required decreases with forward stick/ground speed, while it increases with forward movement, if the wind is actually on the tail. The aircraft “sees” excess power (climb) with forward stick/ground speed, but with the tailwind there is a power deficit (descent) with forward stick/forward movement. What are the implications during a marginal-power approach to a hover with a tailwind?

You’ll remember that the USN workhorse mishap occurred in a dry, high, remote area, with no metro nearby. While the pilots knew the OAT and the pressure altitude at the pad, their (higher-hotter) calculations were based on a no-wind condition. They had no cues by which to make a good guess at the winds, but the ground crew had tried to assist with ribbons tied in the lower branches of nearby trees, and guessing the winds on the tail were zero to six knots. The hover power-check went as previous, and the departure over treed, down-sloping terrain was to be a repetition of the earlier, warmer ones that day. The post-mishap analysis by the manufacturer determined that a five-knot tailwind would have caused a 3.4 percent overestimate of the (constant-power) thrust capability in a no-wind condition. The difference in ground-effect benefit from the point of the hover check (solidly IGE) to the point of the first tree strike (marginally IGE) was another thrust decrement (constant power) of 13.4 percent. The power required to produce hovering thrust was at least 200 horsepower higher just before the first tree impact than it was where the power check was conducted seconds before. In this example, and using Fig. 3,
